USAAMRDL TECHNICAL REPORT 71-28
STATIC AND ROTATING AIR/GAS SEAL EVALUATION

EUSTIS DIRECTORATE
U. S. ARMY AIR MOBILITY RESEARCH AND DEVELOPMENT LABORATORY
FORT EUSTIS, VIRGINIA

CONTRACT DAAJ02-70-C-0024
CURTISS-WRIGHT CORPORATION
WOOD-RIDGE, NEW JERSEY

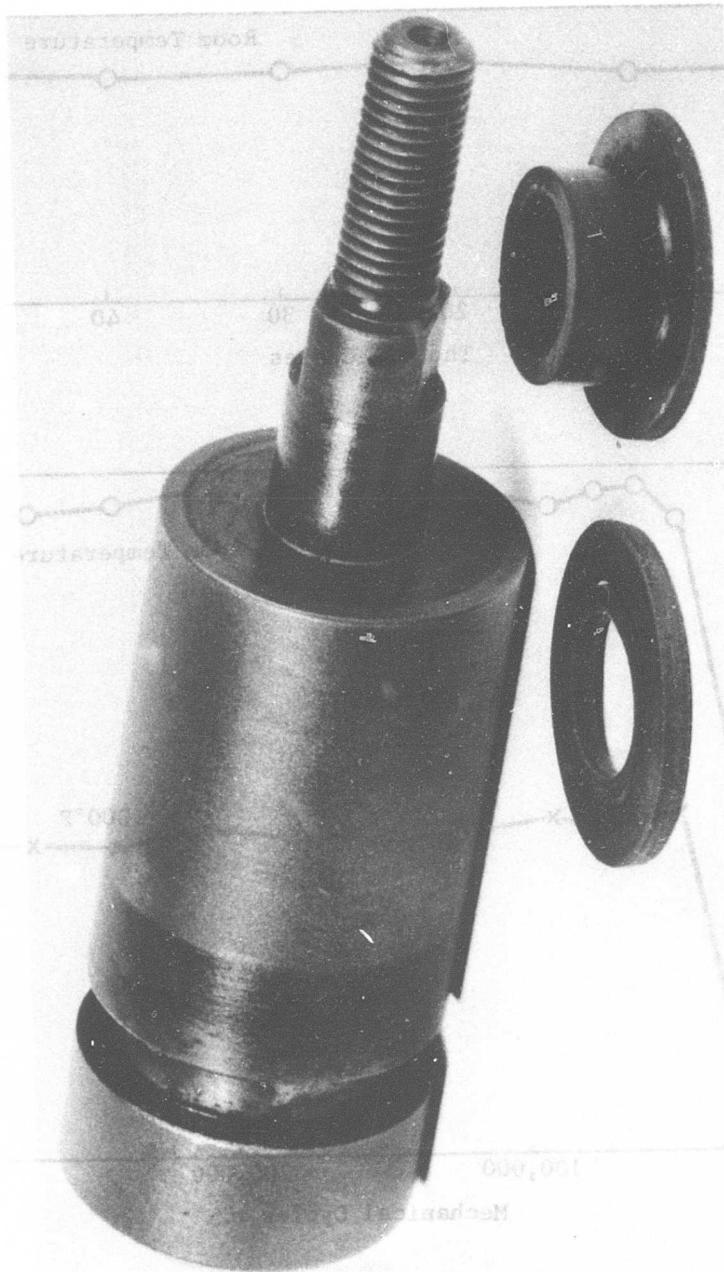
Figure 71. Compressor Variable-Geometry Trunion Mechanism After Testing.

The driving torque for the compressor variable-geometry trunnion mechanism at the start of the 300,000-cycle test was 8 inch-pounds; upon completion of the test, it was 2 inch-pounds. This reduction in the driving torque is an indication of loss of the axial preload due to wear and extrusion of the Rulon-A bushing and washer. There was no change in vane mechanism driving torque as a result of the 50 thermal cycles.
